Failed Diesel Pistons

What the damage may tell you...

BY STEVE SCOTT

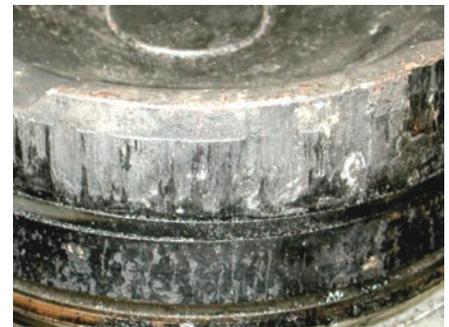
Examining the evidence on a seized piston may indicate whether the seizure originated at the crown, or at the skirt of the piston. In the photo above, the crown is beginning to scuff, and the damage shown is primarily around the top of the piston and progresses downward. This could be the result of over fueling, a timing problem, an air restriction, or inadequate crown cooling.

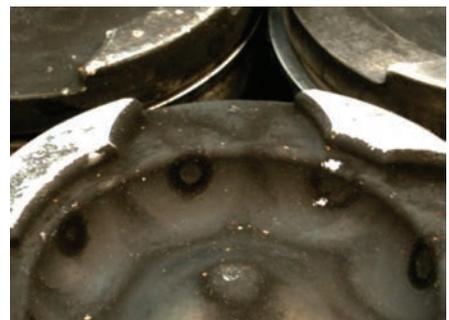
The next photo shows the injection spray pattern high in the piston bowl. Common causes for this occurrence might be advanced injection timing causing detonation and/or lugging, resulting in fuel wash and scuffed rings.

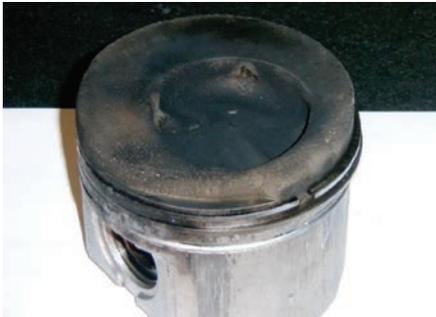
The photo below shows advanced stages of crown erosion. As the crown overheats, it softens, and the injection pressures actually erode the edge of the crown.

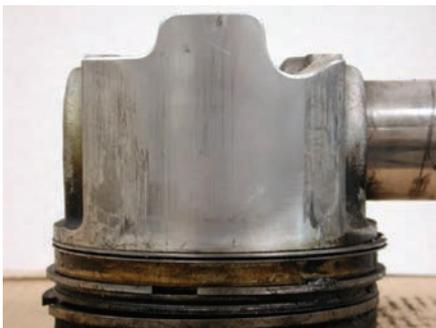
As mentioned earlier, the aluminum piston designs are more susceptible to thermal expansion. This next photo is an example of skirt overheating; however, it can be difficult to determine the root cause. An aluminum piston is thickest at the corners of the pin bosses, and as the piston grows or expands, the clearances to the liner are reduced or eliminated and the piston begins to scuff at what is called the ¼ points of the pin boss. High coolant temperatures, lack of heat transfer, and lack of crown cooling can all contribute to this type of failure.

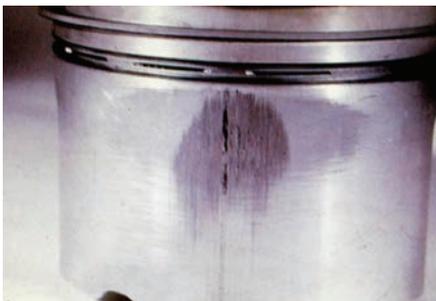
Center point scuffing on the skirt (as shown below) can indicate that the engine has been operating at high RPM or high load too quickly after start up. Depending on how severe and often repeated, this type of skirt damage can continue to expand around the entire skirt and seize the piston.

Most heavy duty pistons at room temperature are not round, they are elliptical (oval), and due to thermal expansion they change dimensionally as they reach operating temperatures. Allowing the engine to warm up gives the piston time to reach the correct operating profile.

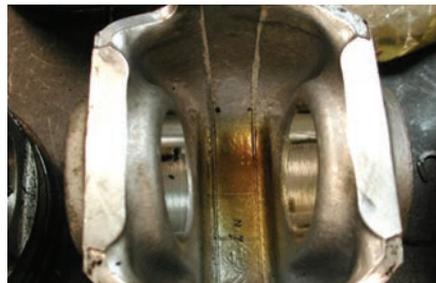
Inspecting the bottom of the piston crown can provide insight into how the piston crown was being cooled. In most engines, a piston cooling jet sprays engine oil on the underside of the piston crown. This absorbs heat from the piston crown and cools the piston skirt. The gold color shown in the photo below indicates there's been a good oil supply and moderate (not too high) crown temperatures.

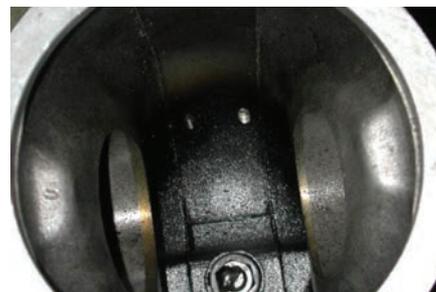
The photo below indicates high crown temperatures. Cooked, burnt, or crusty oil on the underside of the piston confirms there was oil flow while the piston crown was operating at very high temperatures. Lack of discoloration under the crown can indicate that no cooling oil was reaching the crown.

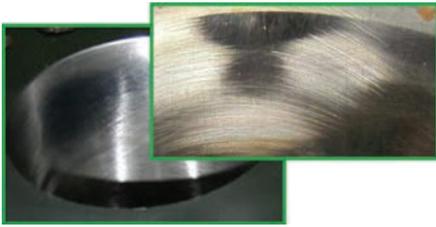
The photos below show polishing on the high spots of a cylinder. While the piston rings can conform to some amount of distortion in the cylinder wall, they cannot conform to larger amounts of variations as shown here. Cylinder bore distortion can result in oil consumption, compression loss and piston seizure in more severe cases.

If a block that distorts in its free state is honed round without a stress plate, the cylinders will not stay round when the engine is reassembled.

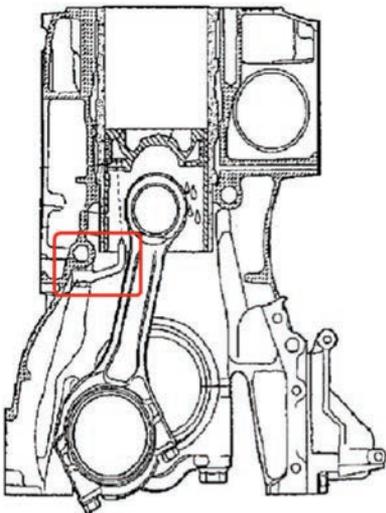
Another component that has contributed to more than its share of piston seizures is the piston cooling jet (or tube) used in some diesel engines. There are several different designs of these tubes, some have a single spray tube, others have twin tubes, and some are made from metal and others are plastic. These tubes spray engine oil up to the bottom of the pistons to cool the piston crowns. Depending on the application, some are adjustable and others are not. One thing they have in common is if they get damaged, plugged, or misaligned, then they can cause piston seizure. If the cooler tube is broken, you may find a small polished or impact area on the tube or piston skirt where the tube was contacting the piston. If not removed, these tubes can also be damaged or broken when the piston and connecting rod assemblies are being installed.

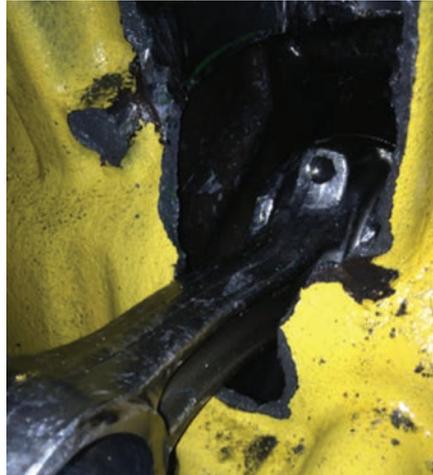
Attention to details during a failure investigation can sometimes uncover some “not-so-common” root causes. The photos below are from an engine that seized a piston and continued to operate until the piston and connecting rod exited the side of the cylinder block.

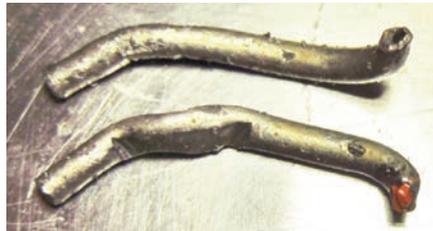
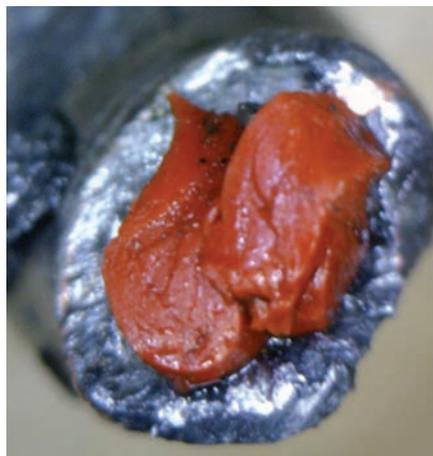
Sorting through the miscellaneous broken pieces found the piston cooling tubes, shown below. Closer examination discovered red sealant packed in one of the tubes. This sealant blocked the oil flow and resulted in a catastrophic failure. Gasket sealants may have their uses, but excessive amounts or even pieces that come loose can cause major problems.

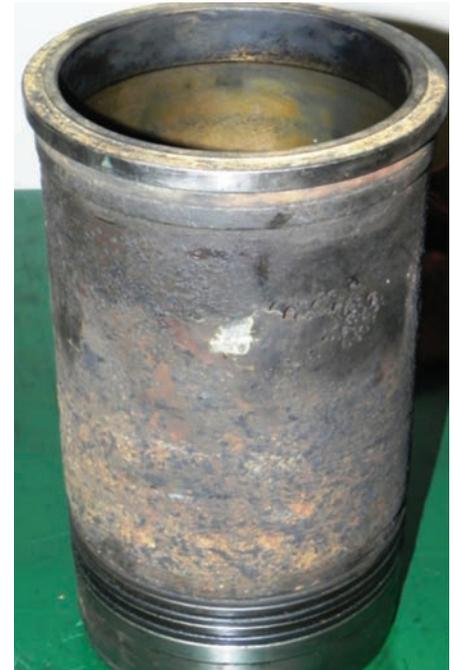
ring to the cylinder liner, and removed by the engine coolant. The engine's cooling system, and the condition of the coolant, is vital to this process. Weak coolant can lead to scale deposits building up on the outside of the liners (as shown in the photo below) and passages of the block, creating a thermal barrier. A 1/16" thick build up of scale can reduce the engines' cooling systems efficiency by 40% (or more) according to various studies. If the heat cannot properly dissipate through the rings, then the piston can overheat.
