Is it really the Water Ferrule's fault?

BY **STEVE SCOTT**

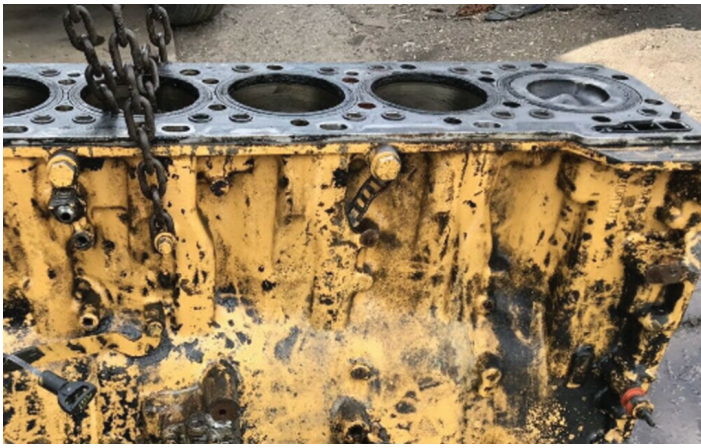
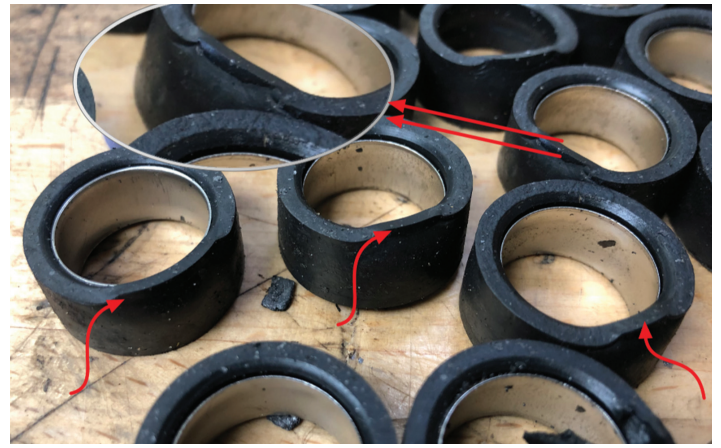
The current 3E6772 water ferrule is made from black HSN (highly saturated nitrile) and incorporates a stainless-steel insert. There is another water ferrule that you may encounter that is not a direct replacement for the 3E6772, or at least not for in-line engines. Listed as an optional replacement by the OEM is the red, 3591439 ferrules. The OEM did not specify the material, but introduced it as having material and design improvements. The 3591439 is primarily listed in V-block engines (3408, 3412, C27, and C32) and in some select applications.

Beyond the color and material, the profiles of these water ferrules are also different. The black 3E6772 is straight sided, slightly taller, and made of softer material. The 3591439 is contoured, shorter, has a smaller insert, and is coated red.

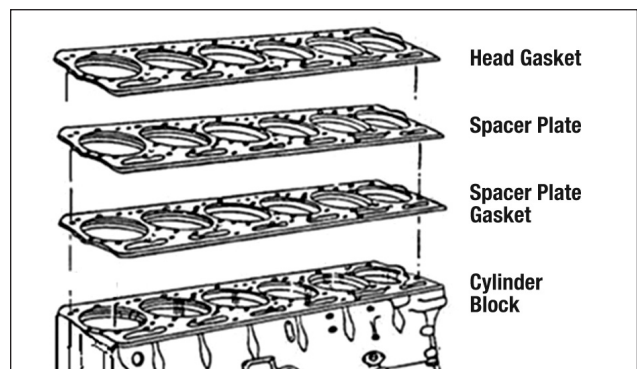
With the spacer plate positioned on a used cylinder head, the photo at the right shows what you would typically expect to see. The water port in the spacer plate and head are aligned leaving an even sealing surface for the water ferrule.

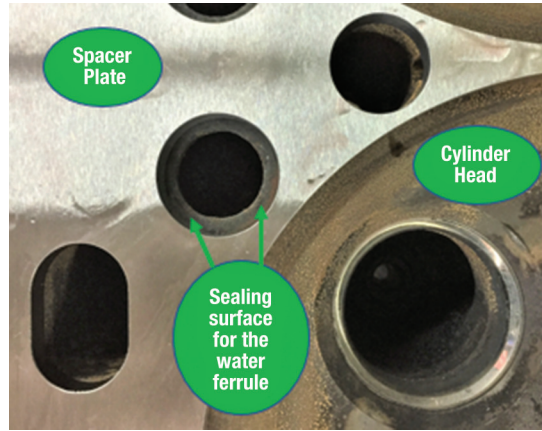
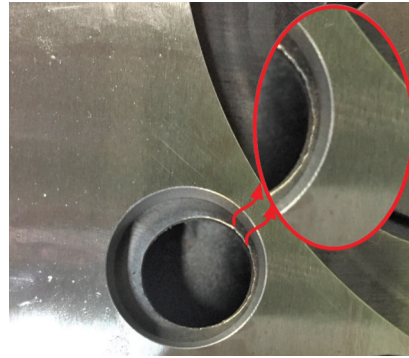
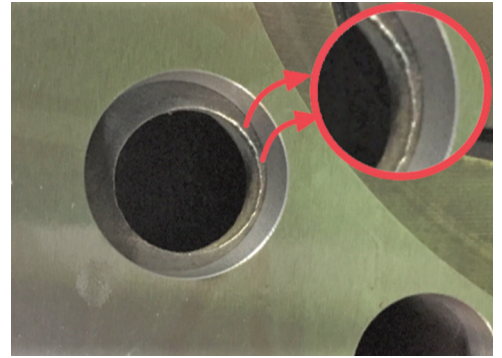
Before assembling these components, you might be amazed at what you may find if you turn the cylinder head over and align the spacer plate on it first. Regrettably, you might be disappointed to find that some of the ports do not align and leave little or no surface for the water ferrule to seal to.

It is possible that the location of the holes in the spacer plate are out of position, and that certainly needs to be investigated and eliminated first since it's the least expensive to replace. Unfortunately, the examples shown in these photos

were confirmed to be problems with the locations of the ports in these cylinder heads. This leaves the rebuilder, or engine owner, in a difficult situation. Depending on how far off the misalignment is, the black 3E6772 ferrule may seal better due to its straight sided profile, or possibly the red 3591439 ferrule due to its shorter height and harder material. If the misalignment is too far off then replacing the cylinder head may be the only option.
