The Devil is in the Details

BY **STEVE SCOTT**

This would likely ruin your day, especially if it happens just 52 miles after an engine was rebuilt. Figures 1 and 2 above show the damage the piston and connecting rod did to the cylinder block and oil pan of this ISX Cummins engine as it quickly began to destroy itself.

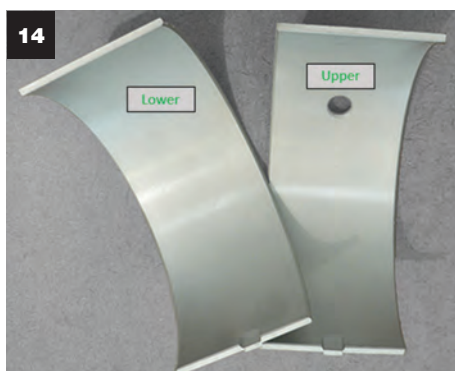
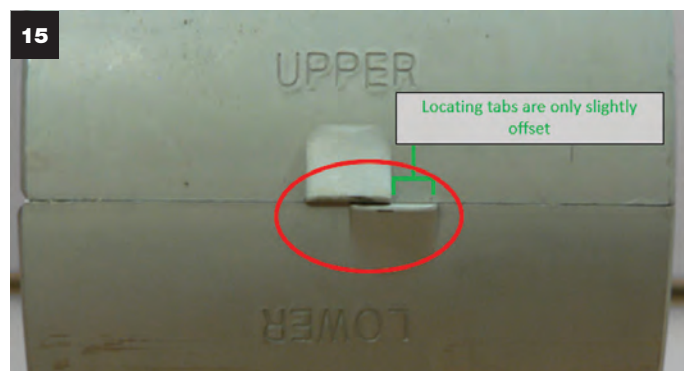
Typically, the connecting rod bearing shells either have identical profiles, and can be installed in either the rod or cap, as shown in figure 12, or they have an upper and a lower shell, where the locating tabs are spaced differently, generally assuring they can only be installed in the correct position, as shown in figure 13.

The ISX saw cut connecting rod bearing shells are positional (similar to figure 13), but the detail that can get overlooked is **the spacing of the locating tabs are so slightly offset they do not prevent the shells from being installed in the wrong position!** (Figures 14 and 15)

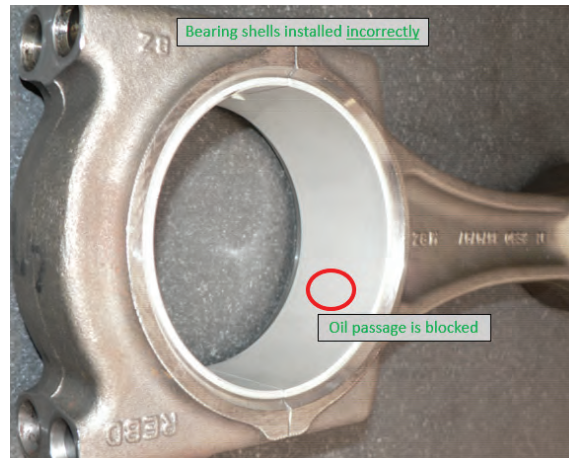
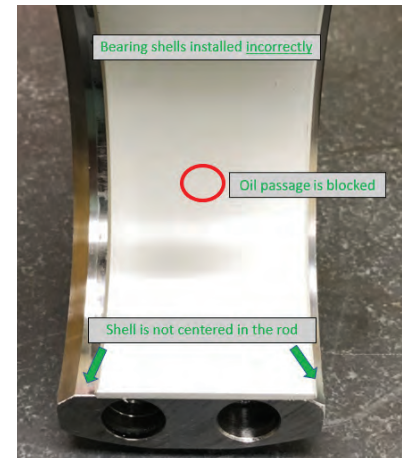
16 INCORRECTLY INSTALLED

Installing them incorrectly is noticeable, as compared in Figures 16 and 17, but the misalignment does allow enough clearance that the connecting rod can still be bolted in place to the crankshaft. If this happens, the engine is destined to fail.

When the shells are installed incorrectly, the edge of the bearing will wear on the fillet radius of the crankshaft, and since the lower shell (which would then be in the upper position) doesn't have the oil supply hole in it, the connecting rod bushing (small end) and piston pin connection fails due to the lack of an oil supply.

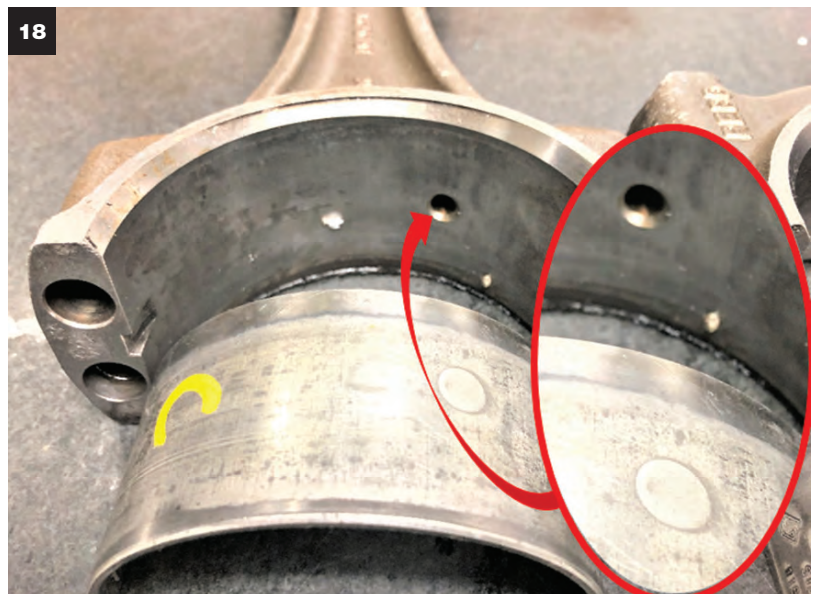
18

A momentary lapse in concentration resulted in the destruction of this engine, and that devilish detail is evident by the mark left by the oil passage in the connecting rod that's clearly visible on the back of the lower rod bearing shell. (Figure 18)

Clearly the manufacturers figured out a solution to this devilish detail to prevent this installation problem with fractured connecting rods. However, with the saw cut rods, it's up to you to pay attention or else the engine may pay the price. ■
