The Puzzle of Engine Failure Analysis

BY STEVE SCOTT

Here is a little background information to help see if you can find the cause of this failure: This was a Cummins ISX engine in a Freightliner truck. Engine had over 900,000 miles on it, and the history of previous repairs or rebuilds is unknown. Engine was in-frame overhauled and ran less than 40 miles before the #3 piston and connecting rod destroyed the cylinder block. There are no ECM records of low engine oil pressure or high engine temperatures.

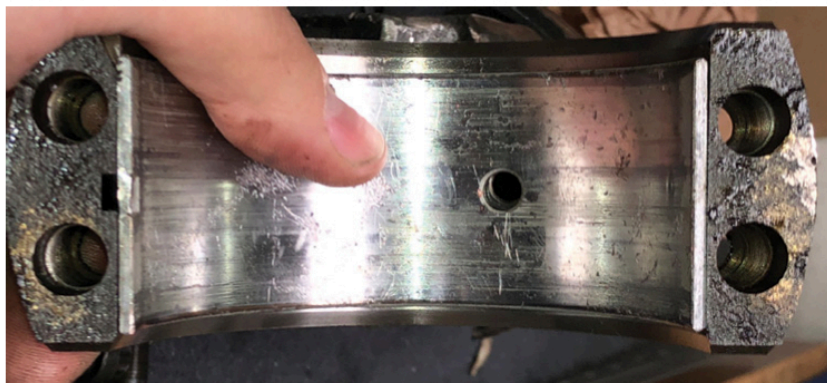
What's the matter with this picture? Hint: There are four visible clues. To make this more interesting the damage on the fractured surfaces of the rod are not part of the equation.

The abnormality that each of the connecting rod bearings had in common was the alignment tabs were gone and each bearing had spun in the connecting rod. This damage was not due to lack of lubrication or lack of torque of the rod bolts.

This cut rod bearing was installed in a fractured rod! The free length of the saw cut bearing allows just enough tension to hold itself in a fractured rod during assembly, and that is the root cause of this failure. A very expensive oversight.

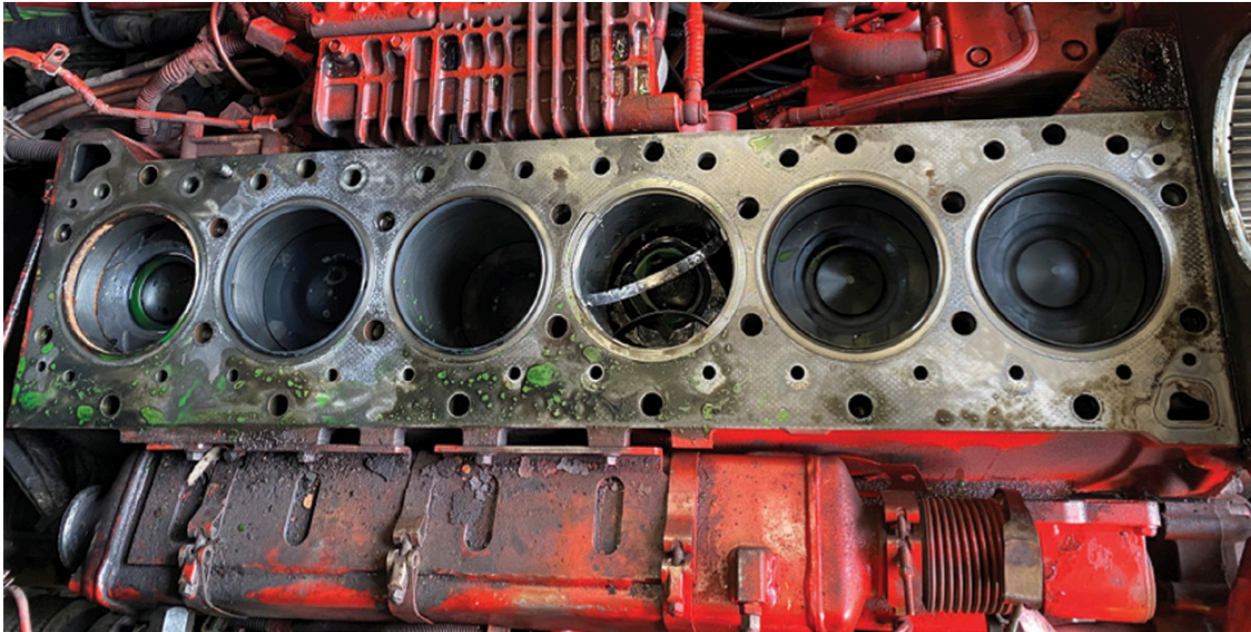
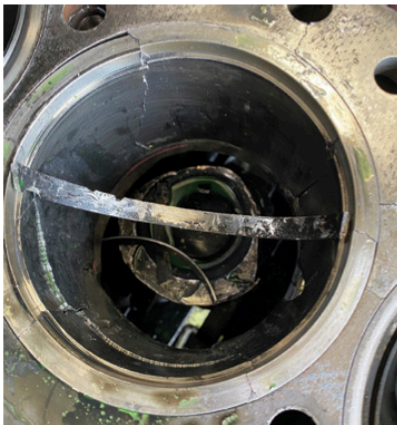
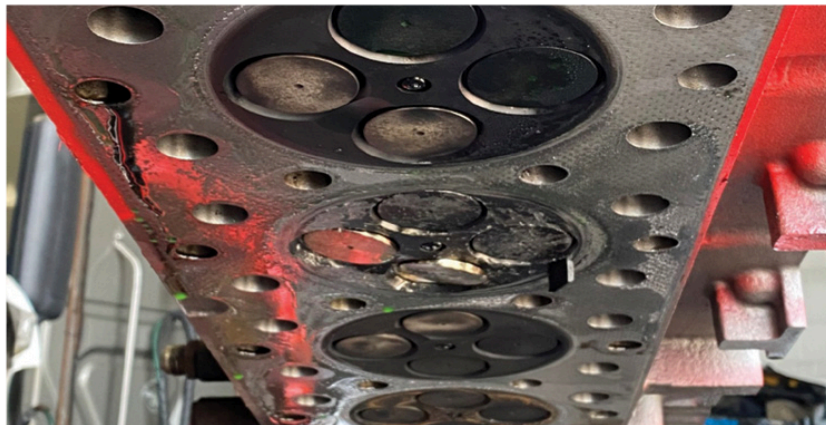
Looking at the bigger picture, removing the cylinder head found the #3 cylinder was destroyed and the cylinder block was cracked. Since there was less than 40 miles on the engine, the question remains whether the piston or liner was defective or out of specifications?

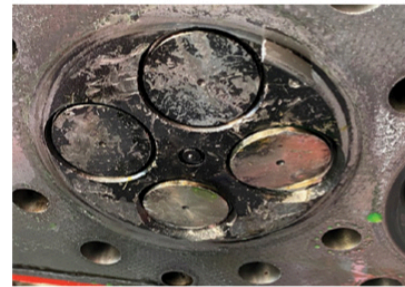
Upon closer look, the cylinder head was damaged, but all of the valves were intact. So dropping a valve was not the problem.

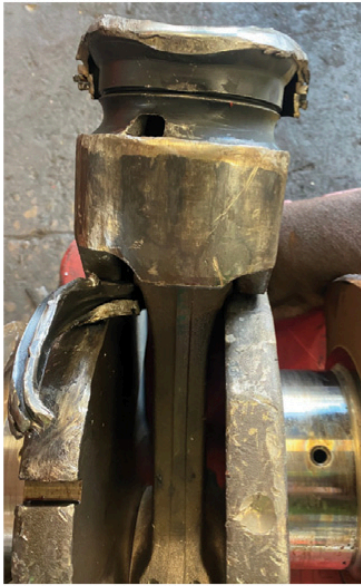
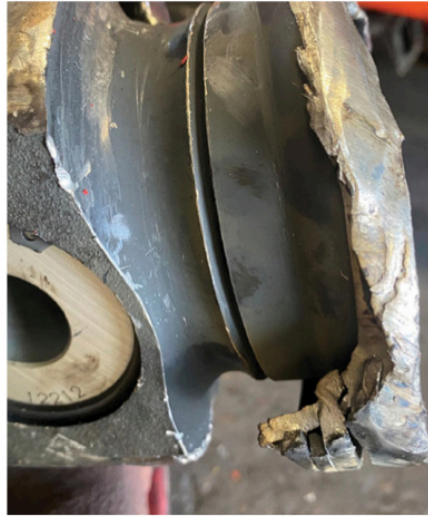
There was a piece of the APR ring jammed into the head. Did the APR ring fail? If you skip ahead to the conclusion of this article you forfeit any remaining kudos.

The entire ring carrier of the piston crown had broken off. There was heavy impact damage. The piston and rod were still attached to the crankshaft.

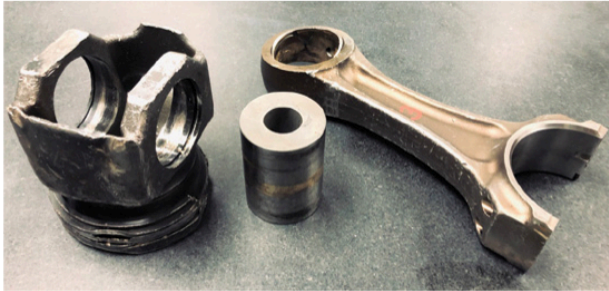
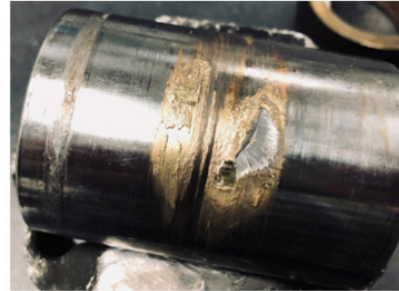
The pin and rod bushing welded themselves together. The primary damage was near the center of the pin and secondary damage near the ends of the pin and to the pin bosses of the piston.

The bushing in the rod had spun and was blocking the oil supply. There was heavy adhesive damage.

The rotation of the bushing caused it to contact the inside of the piston body.

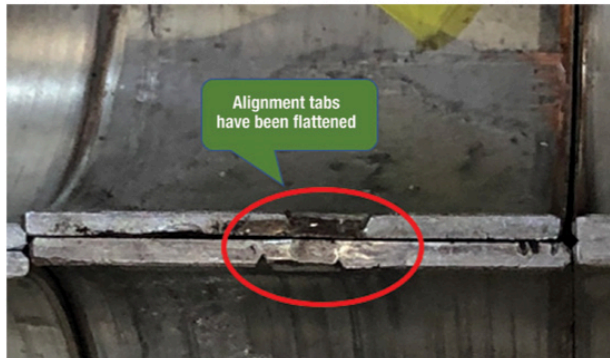
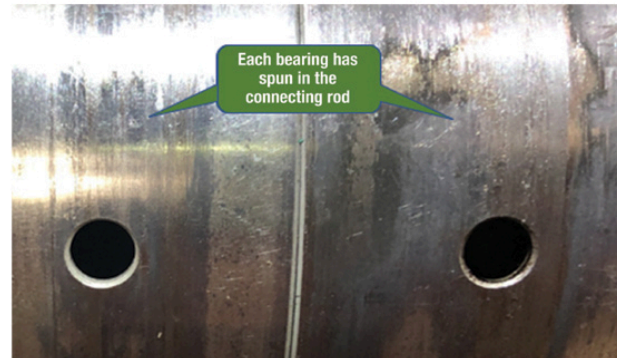
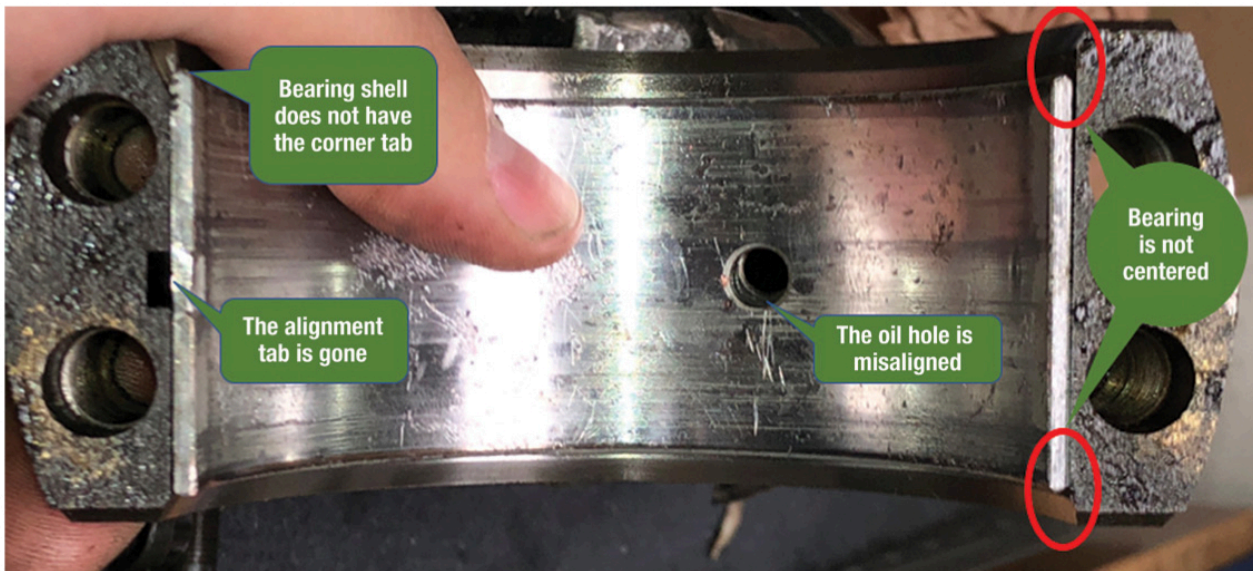
The problem is the design of the connecting rods do not match the design of these rod bearings. There are two different types of connecting rods used in ISX engines, "saw cut" and "fractured". These terms describe the mating surfaces between the connecting rod and rod cap. "Saw cut" rods have been used for years, and "fractured" rods are the newer technology (released in 2012). Cummins allows for these rod types to be mixed in an engine, and if a rod has been replaced all the connecting rods may no longer be the same design. You can have any combination within the six rods. **Matching the correct connecting rod bearing to the correct rod is critical.**

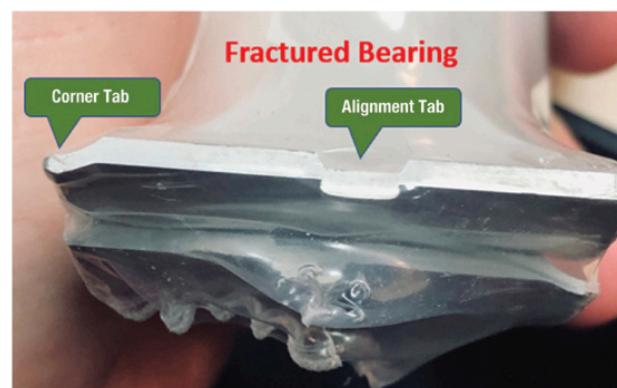
A fractured connecting rod has a 0.032" larger bore for the rod bearing than a saw-cut rod.

- Fractured rod bore spec is 3.9221" to 3.9236"
- Saw Cut rod bore spec is 3.890" to 3.891"

That added clearance allowed all the bearings to rotate in these connecting rods without seizing. Operating forces flatten the alignment tabs, and the rotation blocked the oil supply to the rod bushing (small end) and pin.

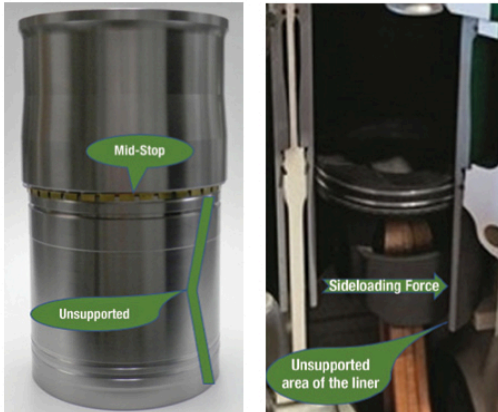
Fractured rods and bearings have an alignment tab, but also a folded corner. Since a saw cut rod does not have the corner relief a fracture rod bearing cannot be installed in a saw cut rod.

Unconvinced? Are you wondering “how can a piston and rod that are still connected to the crankshaft ventilate the cylinder block?” The answer to that lays in the design of the cylinder block and liners. ISX engines use a “mid-stop” liner, meaning the liner is held at the top and mid-way down on the liner. This design leaves the lower section of the liner unsupported by the cylinder block.

The restriction in free movement caused by the bushing rotation, the lack of oil and the seizure of the pin caused excessive side loading of the piston against the liner. The unsupported lower section of the mid-stop cast iron liner cannot withstand the side loading force at the bottom of the piston stroke breaking the liner.

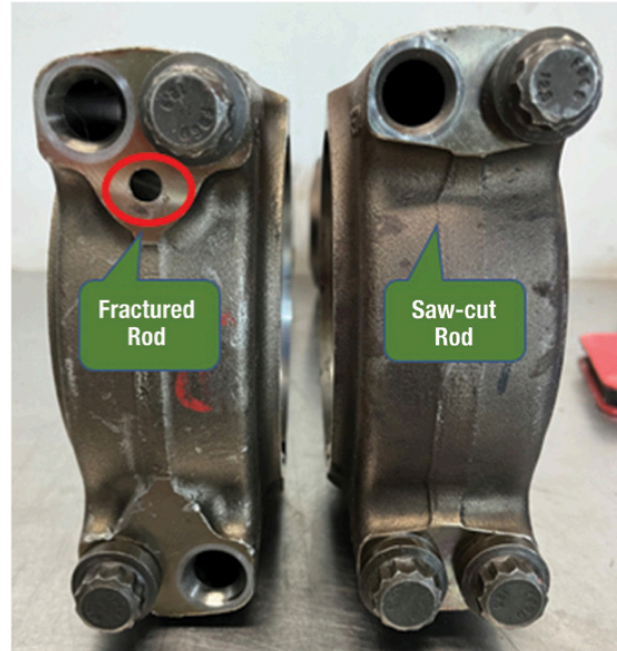
One last snippet of information before we bring this journey to an end. As mentioned in the beginning, there is no way to know for sure which design connecting rods and bearings you will need until the engine is disassembled. Once you can see the bottom of the connecting rods there is a way to tell them apart. The fractured rods have a hole in the cap that the saw-cut rod does not have.
