Dance, Dance, Dance

Cylinder Liner Dancing

BY STEVE SCOTT

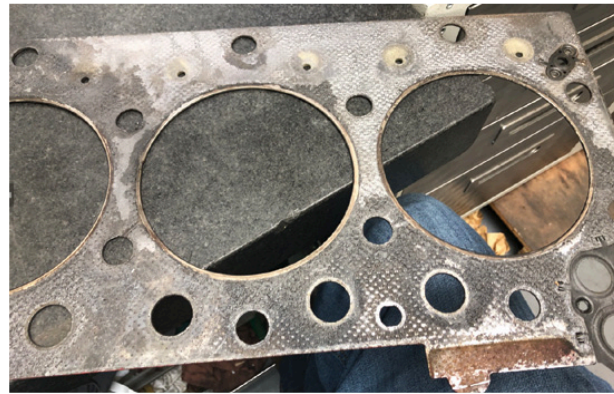
The failed head gasket shown below is from an ISX Cummins engine. The fire wrap on every cylinder is fretted (dance), cracked or burnt.

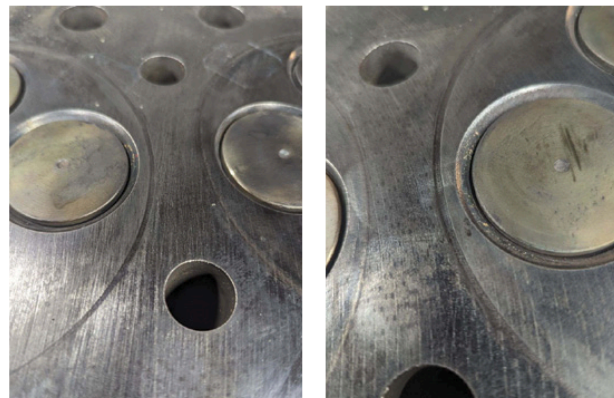
Closer inspection of the components found that every cylinder had surface damage to the cylinder head. This damage was caused by fretting, or movement of the liner (dancing) or head gasket. The head gasket had scrubbed into the head until the gasket could no longer seal. For the head gasket to survive, the upper and lower receiver bores of the cylinder block must be within specs to support the liner, the head bolts must maintain their torque value, and the liner protrusion must remain in spec. If any of these conditions change, the liner can start moving (dance), and the head gasket is doomed to fail.

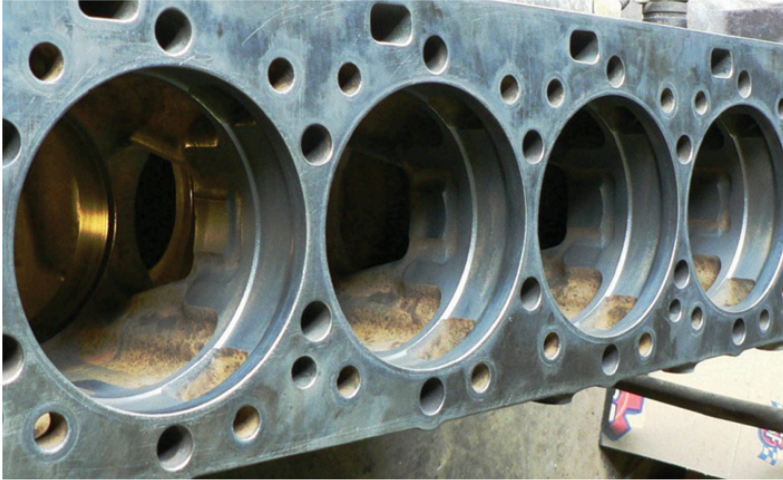
These photos show the top of a worn cylinder block. There's a noticeable ring worn around each of the cylinder bores. This block is in poor shape.

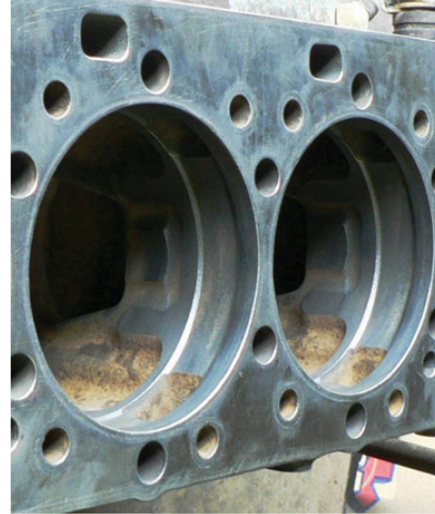
At a slightly different angle (pictured right), the damage is obvious (dance). The wear is well over the .025mm (.001") in depth and covers more than 50 percent of the width of the seat for the liner.

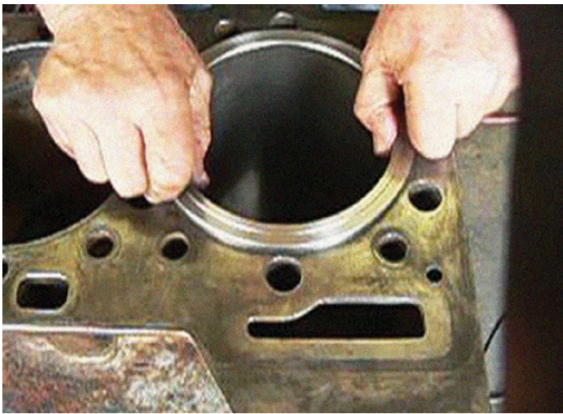
Fretting (dancing) or erosion generally destroys the milling marks on the block surface; however, technicians have reported to have measured blocks that drop off or taper, and the milling marks were still visible. It is always best to measure the block, and not just depend on visual inspection or on the liner protrusion. To help illustrate the point, we took a new cylinder liner and lapping compound, and rotated the liner on this worn block surface just to see how a new liner would contact the block.

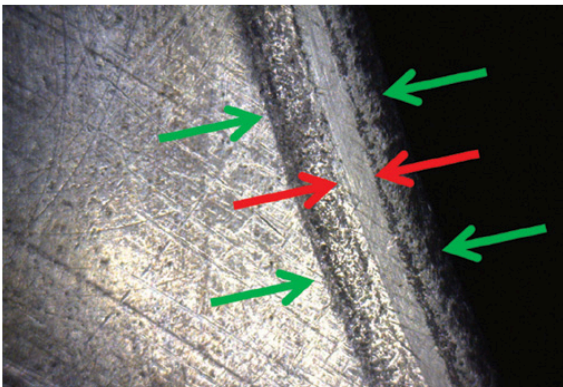
We were not trying to seat the liner, we just wanted to do enough to see a pattern. After removing the liner, the green arrows indicate the width of the worn area from the old worn-out liner flange (dancing). The red arrows indicate where the new liner is now making contact.

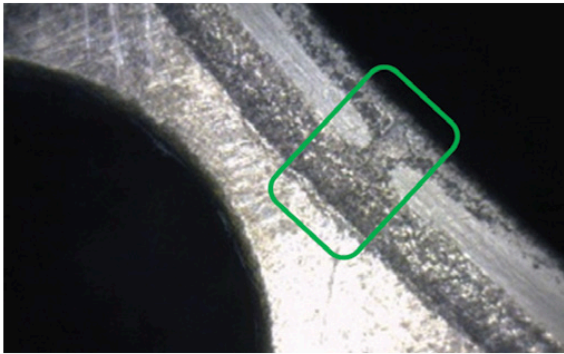
There were also areas where the new liner did not contact the block surface at all.

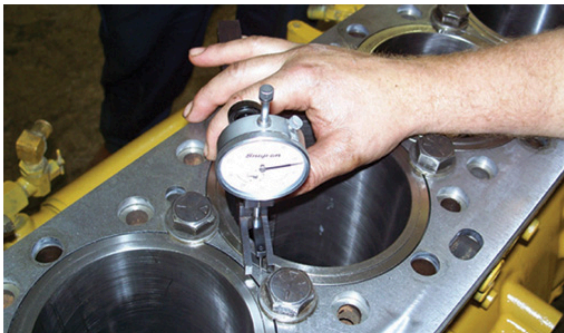
Unfortunately, until the engine is disassembled, and the liners are removed from the cylinder block, there is no way to know the condition of the block surfaces or bores. At this point, the engine owner or repair shop may not be prepared for the added expense and down time to repair the block properly and may decide to assemble the engine back as it is. In this case the liner would be supported only by a narrow ridge instead of the liner sitting firmly on a flat surface. Assembled in this condition, the ridge can be enough to hold the liner up so that the liner protrusion is within the spec range.

However, if placed into service with the liner not seated firmly, the liner will begin to move (dance) under the operating forces of the engine. As that movement wears (dances) the components together, the liner will drop down reducing the liner protrusion and the clamping force on the fire ring of the head gasket. At some point the head gasket may no longer be able to maintain a positive seal, and through no fault of its own the head gasket will fail. In some instances, although the head gasket had failed, the liners and block may have worn together and the liner protrusion is still within specification. For example, a Cat C-15 liner protrusion or projection spec is 0.025-0.152mm (0.001-0.006"), a Cummins ISX is 0.18-

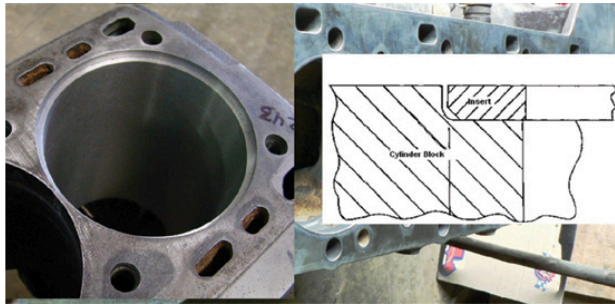
0.30mm (0.007-0.0112”), so the liner can wear (drop) 0.005” and still be in spec, but the crush on the head gasket has been reduced. If a new head gasket is installed and torqued down on the lower liner protrusion regaining the proper crush on the head gasket the second head gasket may survive, but if it does, then this it is NOT an indication that the first head gasket was defective, nor that the second head gasket was of better quality.

For a block to be repaired correctly, it may need to be resurfaced and/or machined. To repair the block, the damaged areas are cut out, and inserts are installed restoring the liner seat. Often, this can be done with the engine still in the chassis. The quality and fitment of the insert is critical. This is not a time or place to use cheap/low quality parts, nor a job for a machinist that does not know what they are doing. The insert must stand up to the same forces as the original cylinder block, and the fitment must

support the insert. If the insert moves or crushes, you are right back in the same situation as before(dancing), but with more expense and less block material to work with for the next repair.
