Dependable Cummins ISX

BY **STEVE SCOTT**

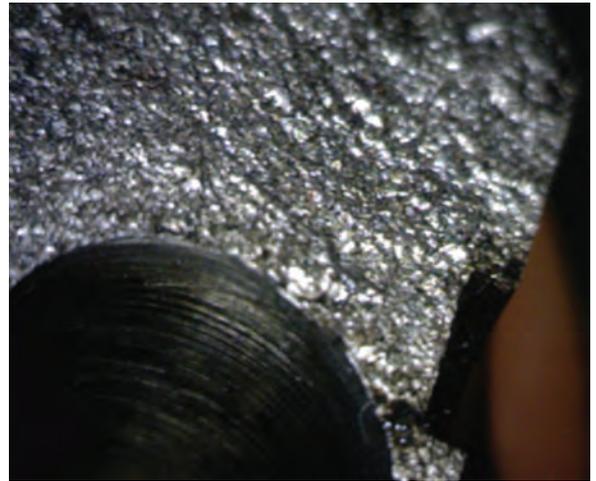
Correct Rod Cap Mating Surface
(Use again, like new condition)

Each time the fractured joint is separated; small amounts of debris may be produced. The surfaces should be carefully cleaned with solvent and a soft nylon brush; do not use a wire brush or coarse method when cleaning these surfaces. If the parting line between the rod and cap is not visible, you do not have to remove the cap to identify the rod type. A fractured rod has a small hole on the bottom for the rod cap and a machined rod does not have a hole in the cap.

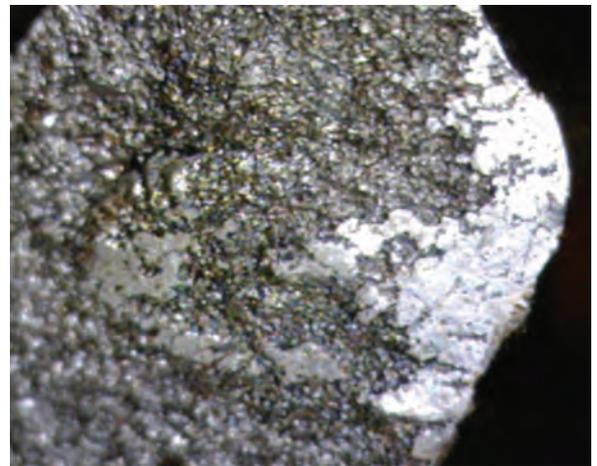
are handled. If they are assembled and the bolts are not tightened, the surfaces will scrub together and the rod will not torque correctly when reassembled. Something as simple as dropping the cap or temporarily putting it on backwards will damage the surfaces. These rods must be replaced if there is any damage to the mating surfaces of the rod or cap.

Damaged Rod Cap Mating Surface
(Do not reuse, damaged condition)

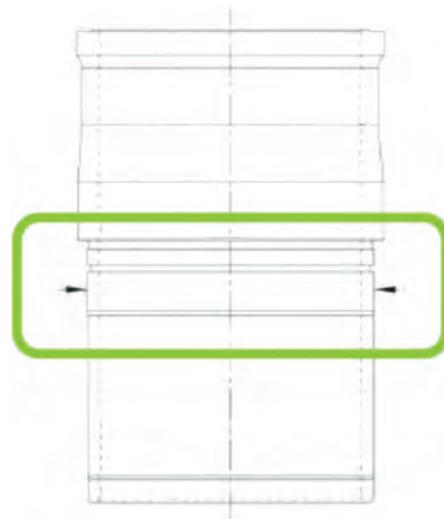
As you can see by the dimensions listed by the diagram at the far right, the reference to small/large is really not that much (2mm) and great attention (no eyeballing here) to this area is required during parts ordering and engine assembly.

IMPORTANT NOTE: A small outside diameter cylinder liner will visually appear to have been correctly installed into a large bore cylinder block. However, because of the smaller outside diameter of the cylin-

der liner, it will fit loosely into the cylinder block at the cylinder liner O-ring sealing area. This will result in excessive cylinder liner movement in the cylinder block and possible leakage.

Large Bore Block O.D. 5.984" (152 MM)
Small Bore Block O.D. 5.906" (150 MM)
