Engine Failure Analysis: **Look Beyond the Obvious**

BY **STEVE SCOTT**

In this case, it happened to a Caterpillar model 3306 engine. The 3306 engines have been around for decades and have proven to be a tough workhorse of an engine that aren't prone to having problems. As the story goes, the engine shown in these photos had a valve fail right after being rebuilt and placed into service.

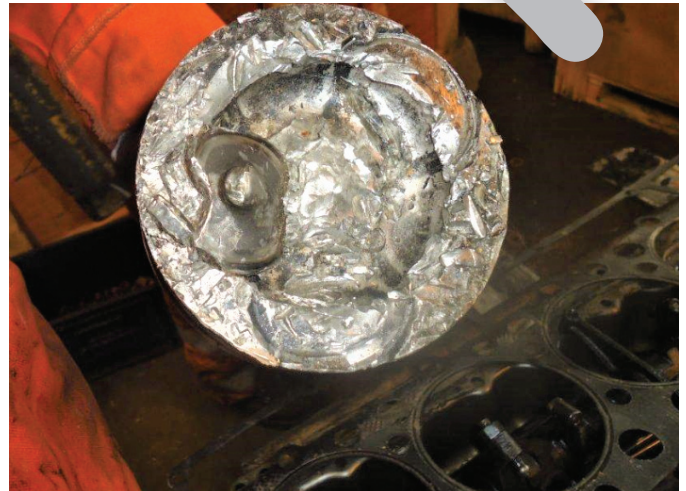
The head of the valve is lodged in the crown of the piston. There're no signs of piston seizure.

With the rocker arm being unable to move freely, the valve was held in the open position and was impacted by the piston, breaking the valve and damaging the piston and cylinder head. No doubt those involved in building this engine have tried to recount how this could have happened, why the problem wasn't detected during assembly or while adjusting the valves. A bizarre chain of events, and the damage follows a clear timeline of the failure.

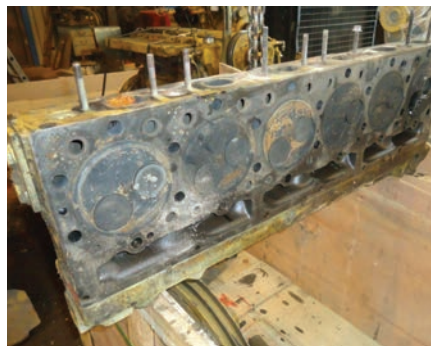
The cylinder head is damaged, and the valves are no longer in the failed cylinder.

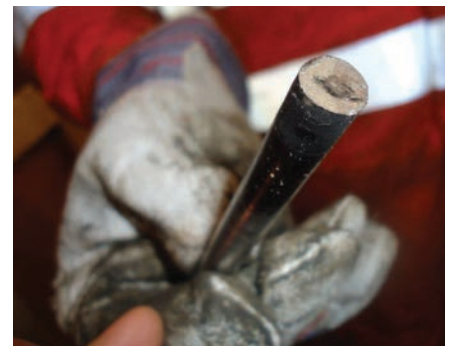
The failed valve stem is straight.

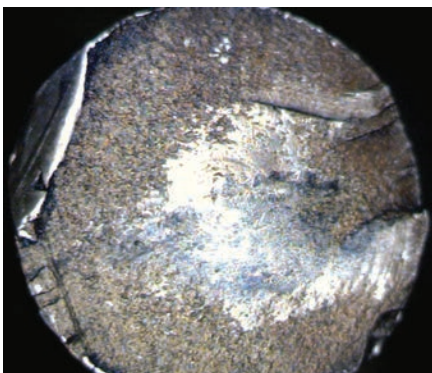
There is minimal impact damage to the fractured end of the stem.

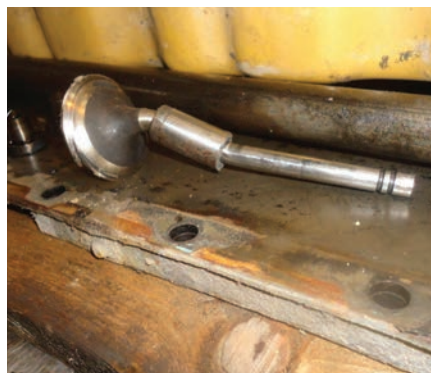
The other valve from the failed cylinder is bent and the guide is broken.

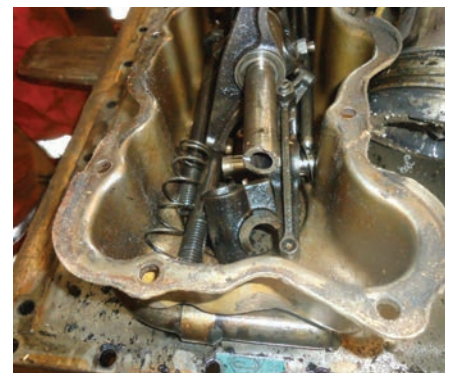
Assorted rocker arm components and push rods were removed and stacked in the valve cover.

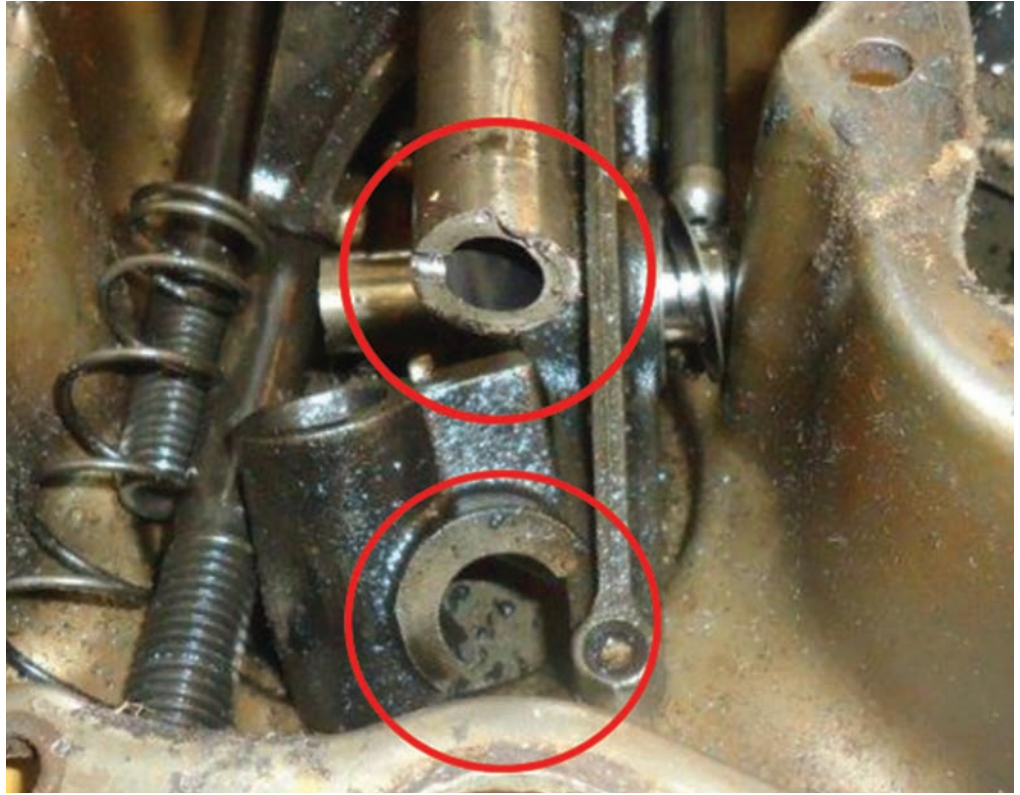
The broken rocker arm shaft and bracket are not commonly damaged during a valve failure. Typically, the push rods would be bent, but the bracket and shaft would be unharmed.

The force from a failed valve, especially without any major impact to the valve cannot

reasonably break the rocker shaft or bracket.

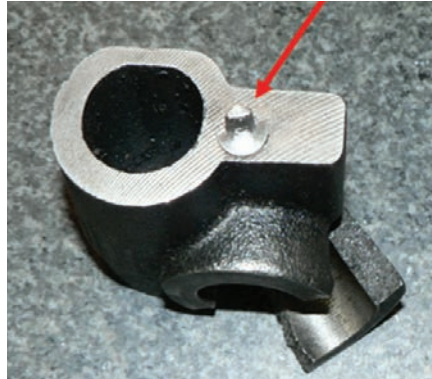
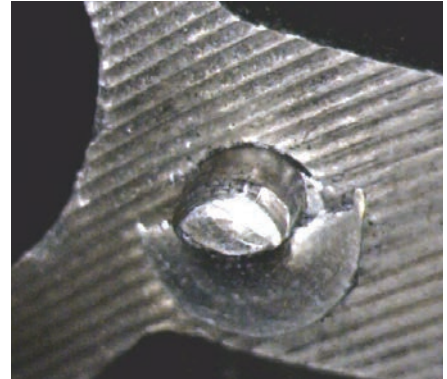
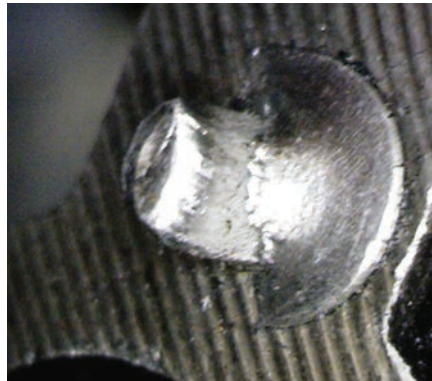
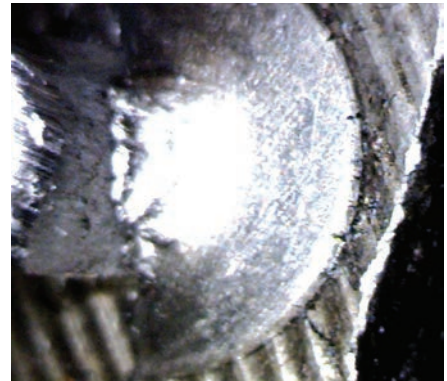
The dowel material has been crushed between the bracket and head in a way that the bracket cannot seat flat to the cylinder head. With the bracket seating unevenly on the cylinder head, the force from torque of the bolt placed an undue stress on the rocker arm shaft, causing it to bend, and eventually break.

The rocker shaft bracket in this application has an alignment dowel that centers the bracket to the cylinder head. Closer inspection of the bracket found the alignment dowel in this bracket has been severely damaged. The dowel material has been crushed between the bracket and head in a way that the bracket cannot seat flat to the cylinder head. With the bracket seating unevenly on the cylinder head, the force from torque of the bolt placed an undue stress on the rocker arm shaft, causing it to bend, and eventually break.
