Dependable Cummins ISX

BY **STEVE SCOTT**

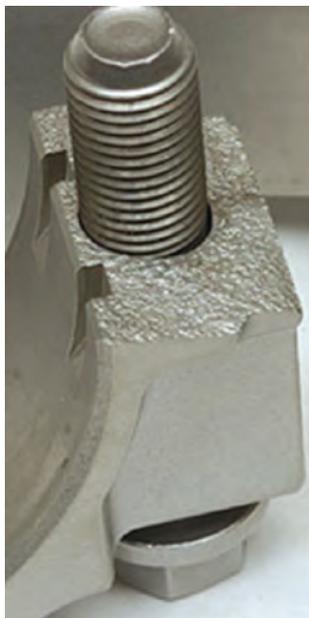
More commonly known currently are the issues surrounding the “drilled” vs. “non-drilled” type connecting rods. There is, however, a third design connecting rod to consider, a “fractured” type, which seems to be the trend in connecting rods. The earlier rods have machined surfaces between the rod and rod cap mating surfaces, whereas fractured rods have rough surfaces on both the rod and cap. The rough surfaces resulting from the rod being fractured during the manufacturing process as shown in the photo at the right.

RIGHT: Fractured Rod Cap Surface

Special care must be used when handling fractured connecting rods. The rod cap should be kept completely separated from the rod, or tightened correctly to the rod whenever the parts

are handled. If they are assembled and the bolts are not tightened, the surfaces will scrub together and the rod will not torque correctly when reassembled. Something as simple as dropping the cap or temporarily putting it on backwards will damage the surfaces. These rods must be replaced if there is any damage to the mating surfaces of the rod or cap.

Each time the fractured joint is separated; small amounts of debris may be produced. The surfaces should be carefully cleaned with solvent and a soft nylon brush; do not use a wire brush or coarse method when cleaning these surfaces. If the parting line between the rod and cap is not visible, you do not have to remove the cap to identify the rod type. A fractured rod has a small hole on the bottom for the rod cap and a machined rod does not have a hole in the cap.
