Failed Diesel Pistons

What the damage may tell you...

BY STEVE SCOTT

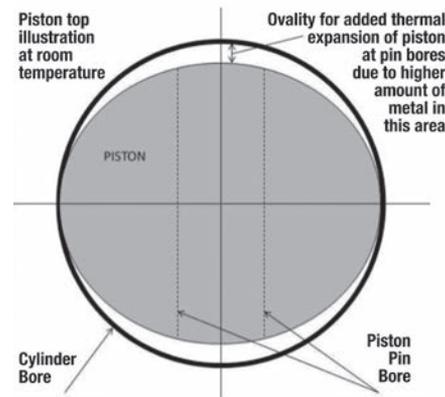
Most heavy duty pistons at room temperature are not round, they are elliptical (oval), and due to thermal expansion they change dimensionally as they reach operating temperatures. Allowing the engine to warm up gives the piston time to reach the correct operating profile.

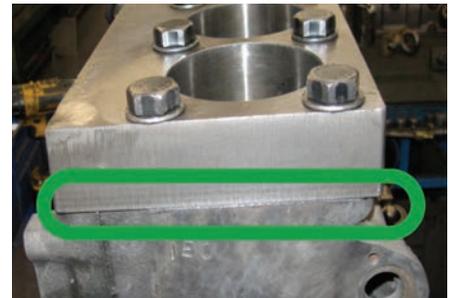
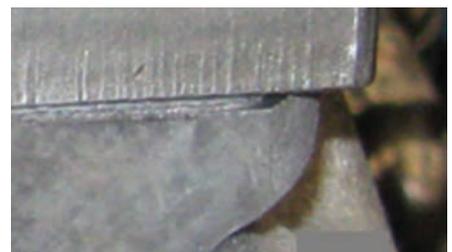
Checking maintenance records and/or checking critical event codes (on engines equipped with an ECM/electronic control module) are good sources of information. Sometimes, common causes of seizure can be identified by looking into an engine's history. If the engine has been operating successfully for an extended amount of time, you may be able to eliminate some of the possible causes. Obviously a failure could be from a defective part; however, a fitment problem between the piston and cylinder would most likely be evident shortly after assembly. Likewise, something as simple as rolling a cylinder liner o-ring during installation can distort the cylinder liner, reducing clearances and resulting in a hot spot that can lead to piston seizure.
