Is it really the Water Ferrule's fault?

BY **STEVE SCOTT**

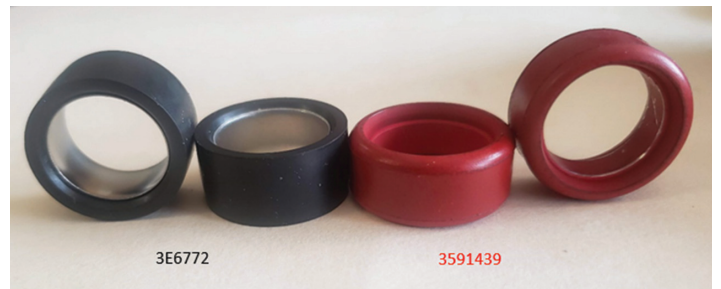
The current 3E6772 water ferrule is made from black HSN (highly saturated nitrile) and incorporates a stainless-steel insert. There is another water ferrule that you may encounter that is not a direct replacement for the 3E6772, or at least not for in-line engines. Listed as an optional replacement by the OEM is the red, 3591439 ferrules. The OEM did not specify the material, but introduced it as having material and design improvements. The 3591439 is primarily listed in V-block engines (3408, 3412, C27, and C32) and in some select applications.

Beyond the color and material, the profiles of these water ferrules are also different. The black 3E6772 is straight sided, slightly taller, and made of softer material. The 3591439 is contoured, shorter, has a smaller insert, and is coated red.
