The Devil is in the Details

BY **STEVE SCOTT**

This would likely ruin your day, especially if it happens just 52 miles after an engine was rebuilt. Figures 1 and 2 above show the damage the piston and connecting rod did to the cylinder block and oil pan of this ISX Cummins engine as it quickly began to destroy itself.

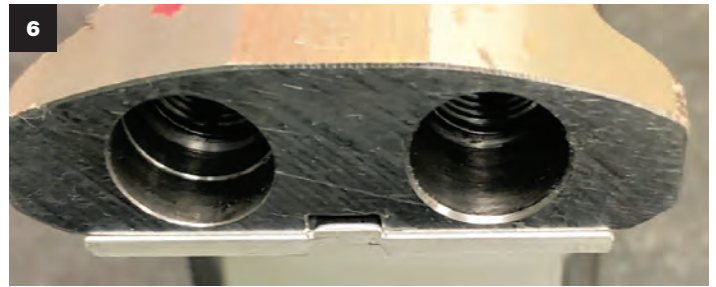
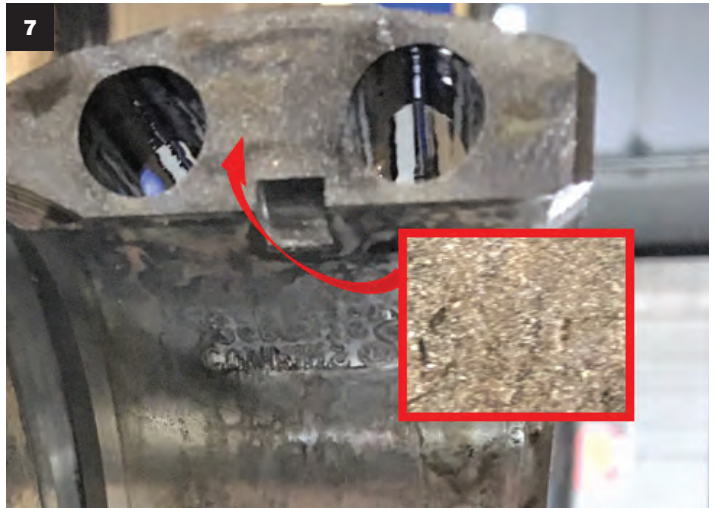
“Fractured” rods are the newer technology. These rods are forged as one piece and then the cap section is fractured from the larger rod section. Fracturing the sections leaves uniquely matched rough surfaces between the rod and cap. (Figures 6 and 7)

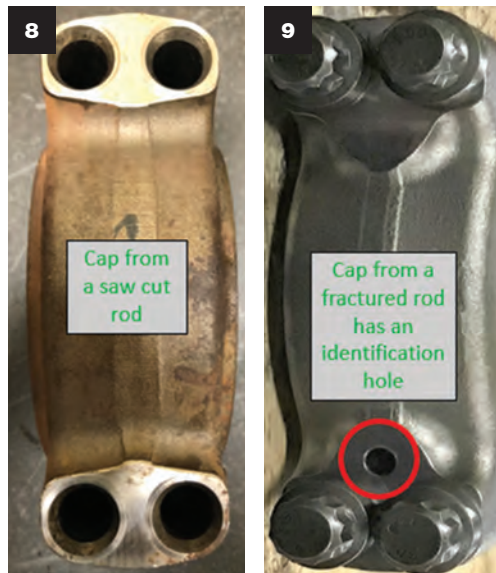
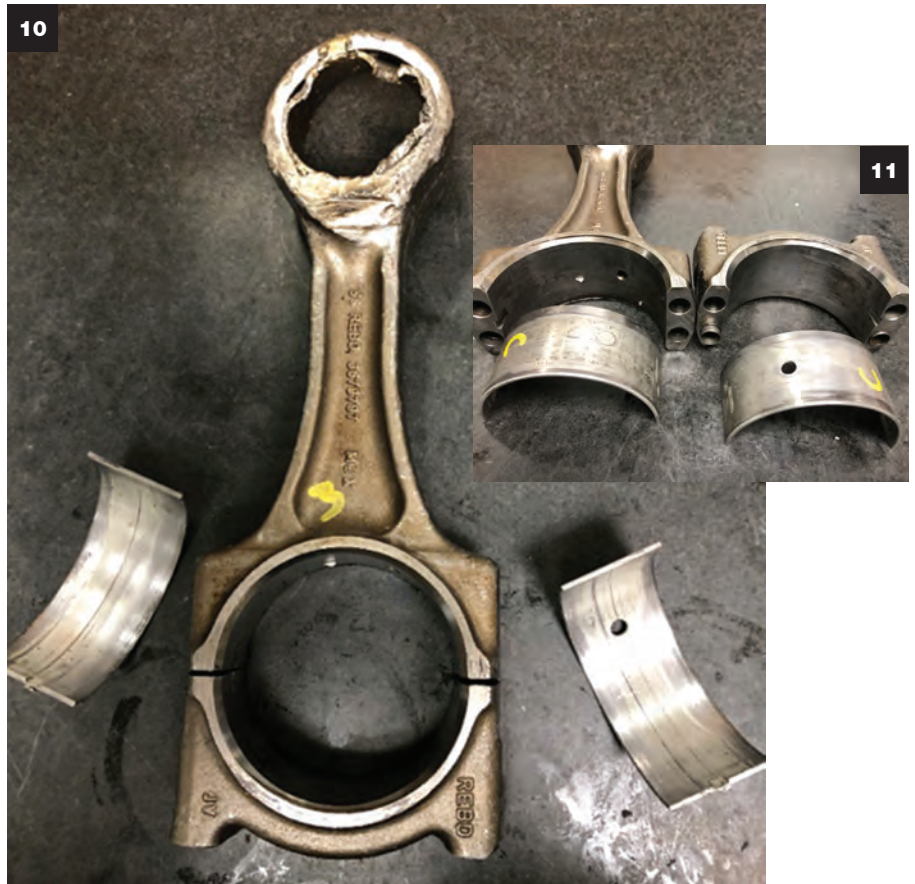
Saw cut vs. fractured rods can also be identified by the design of the cap. The cap from a fractured rod has a hole that a saw cut cap does not. (Figures 8 and 9)
