The Puzzle of Engine Failure Analysis

BY STEVE SCOTT

Here is a little background information to help see if you can find the cause of this failure: This was a Cummins ISX engine in a Freightliner truck. Engine had over 900,000 miles on it, and the history of previous repairs or rebuilds is unknown. Engine was in-frame overhauled and ran less than 40 miles before the #3 piston and connecting rod destroyed the cylinder block. There are no ECM records of low engine oil pressure or high engine temperatures.

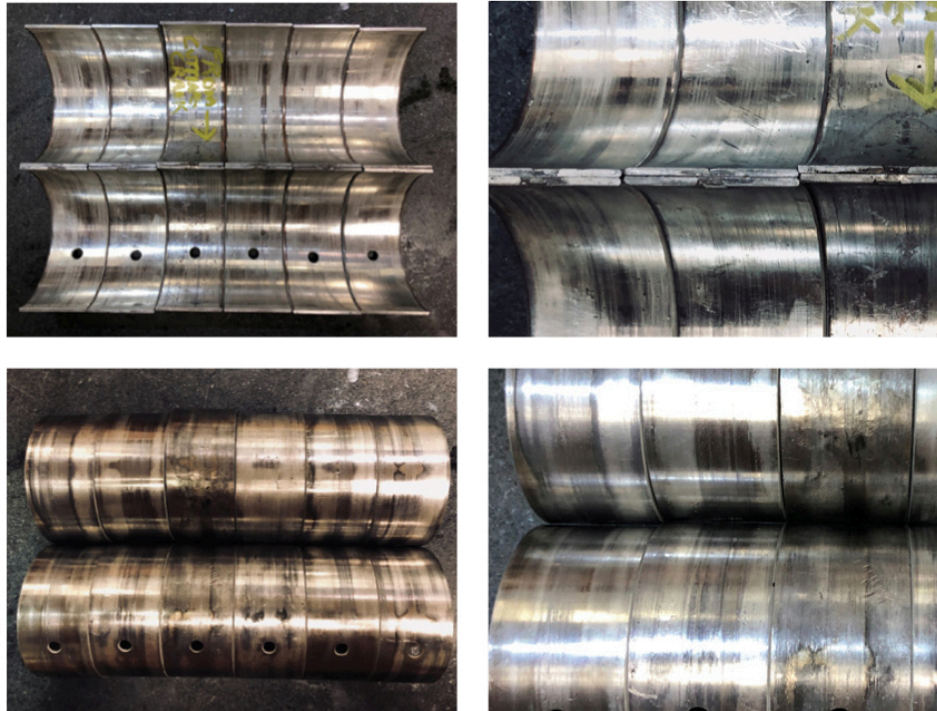
Pictured right are all six of the connecting rod bearings. The #3 bearing was from the failed cylinder. Do you see anything odd in these photos? There are two major details they all have in common.

Did you find them? If not, take a look at the close-up photos (far right) and I think you will see what I have been leading up to. No cheating, we are almost to the end.

The abnormality that each of the connecting rod bearings had in common was the alignment tabs were gone and each bearing had spun in the connecting rod. This damage was not due to lack of lubrication or lack of torque of the rod bolts.

The problem is the design of the connecting rods do not match the design of these rod bearings. There are two different types of connecting rods used in ISX engines, "saw cut" and "fractured". These terms describe the mating surfaces between the connecting rod and rod cap. "Saw cut" rods have been used for years, and "fractured" rods are the newer technology (released in 2012). Cummins allows for these rod types to be mixed in an engine, and if a rod has been replaced all the connecting rods may no longer be the same design. You can have any combination within the six rods. **Matching the correct connecting rod bearing to the correct rod is critical.**

This cut rod bearing was installed in a fractured rod! The free length of the saw cut bearing allows just enough tension to hold itself in a fractured rod during assembly, and that is the root cause of this failure. A very expensive oversight.
