Dance, Dance, Dance

Cylinder Liner Dancing

BY STEVE SCOTT

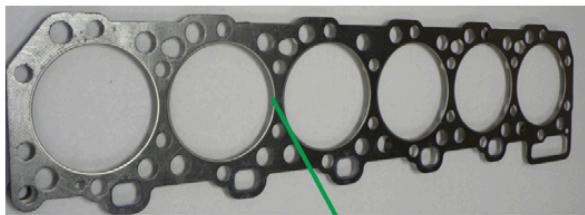
Head gaskets are commonly made by bonding layers of metal core and composite materials. The number of layers of each varies by application and manufacturer. The bonding agents may be chemical, mechanical, or a combination of both. As shown in the example below, the fire ring is surrounded by a fire wrap. The wire material is formed into a circle and welded to create the fire ring. The diameter of the wire and the weld are critical. The weld must be able to crush consistently with the wire, and the fire wrap must be flexible enough to crush without fracturing when the cylinder head is torqued in place.

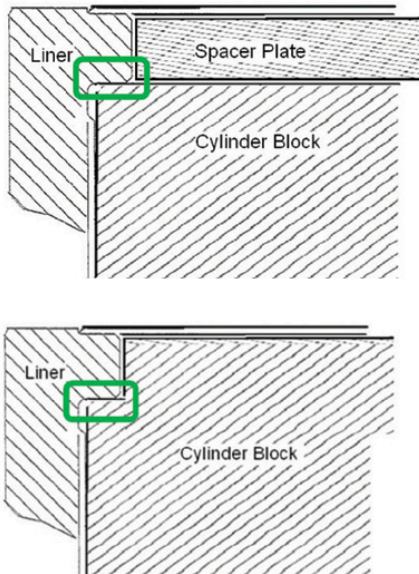
Many of the Cat® engine models are “spacer-plated” engines, meaning that on top of the cylinder block is a spacer plate gasket, followed by a spacer plate, then the head gasket, and finally the cylinder head. The liner flange sits directly on the surface of the cylinder block. On non-spacer plated engines, the liner sits down in a counter bore of the block eliminating the need for the spacer plate gasket and spacer plate. “Parent bore” engines do not have replaceable liners and the head gasket sits direct on the block.

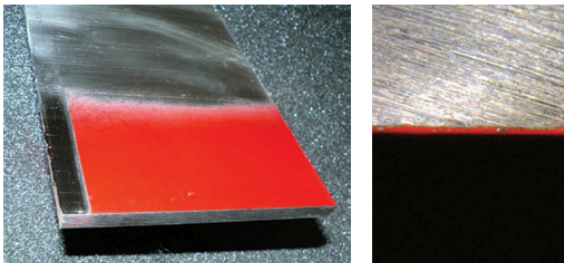
Whether the engine is spacer plated or non-spacer plated, one area that doesn't get enough attention is the surface of the block that supports the liner flange. Journeymen technicians and machinists understand how critical this area is for properly supporting the cylinder liner, and for maintaining the positive seal of the head gasket. As an example, an OE specification for flatness on a Cat 3406 or C15 engine over the entire cylinder block surface must be within 0.10mm (0.004”) and cannot vary more than 0.05mm (0.002”) over any 150mm (6”) to 177mm (7”) section of the block's surface, depending on the specific application. However, the specification for damage to the liner seat area is not more than .025mm (0.001”) deep in localized areas and cannot be more than half the width of the seat. 0.001” of an inch is not very much, in fact it's less than the thickness of the paint we sprayed on this piece of aluminum.

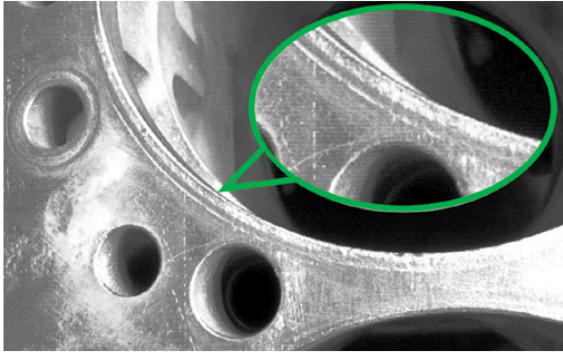
Fretting (dancing) or erosion generally destroys the milling marks on the block surface; however, technicians have reported to have measured blocks that drop off or taper, and the milling marks were still visible. It is always best to measure the block, and not just depend on visual inspection or on the liner protrusion. To help illustrate the point, we took a new cylinder liner and lapping compound, and rotated the liner on this worn block surface just to see how a new liner would contact the block.
